6. SOME METHODOLOGY ASPECTS REGARDING THE ORGANIC DEPOSITS REMOVAL INTERVENTIONS IN THE PROTHESIS OF THE CHURCH OF DRAGOMIRNA MONASTERY

Abstract: *Less visible to the general public, the area of the Prothesis inside the sanctuary of the “Pentecost” heritage church, of Dragomirna Monastery, shows a particular casuistic due to the diversity of types of degradation recorded at the time of its restoration (2011). The dominant form is the adherent candlewax deposits, present on the surface of the paint layer in various stages of hardness. The particular state of conservation features occurring in this area, corroborated with a series of aggravating environmental factors, imposed the application of a special restoration intervention methodology in the area of the Prothesis.*

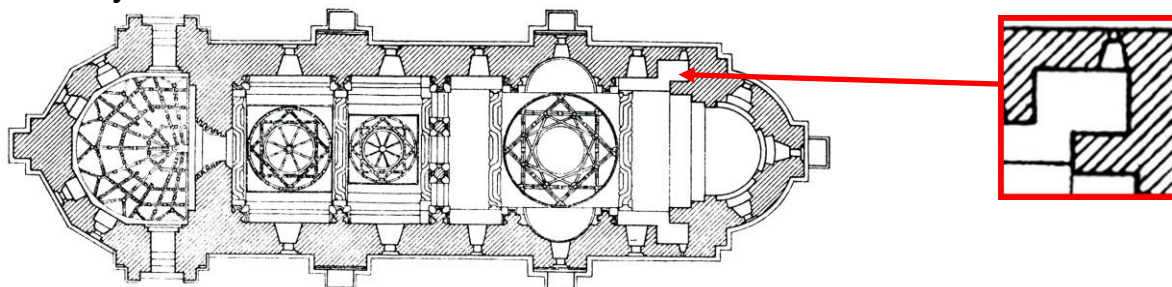
Figure 5. The localization of the intervention area on the ground plan

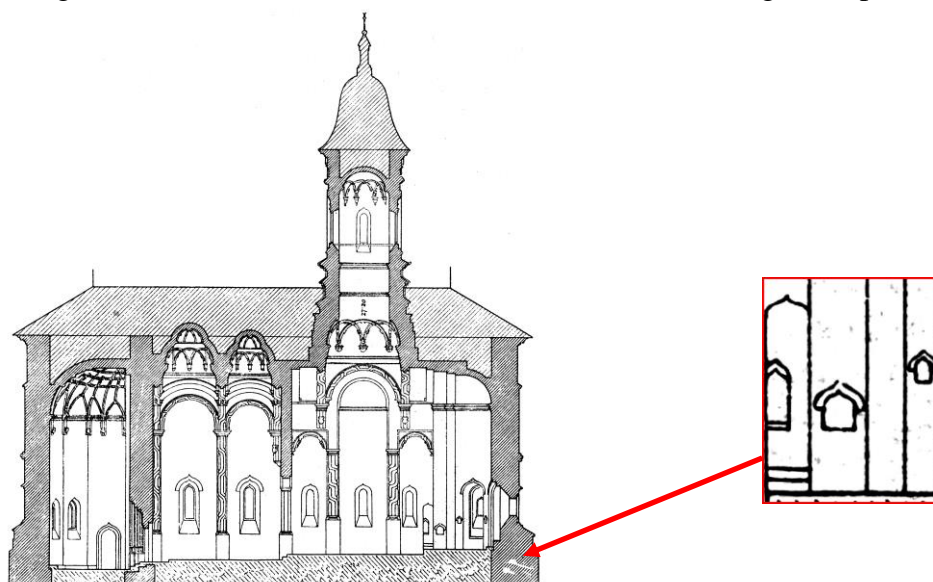
Figure 6. The localization of the intervention area on the axial section

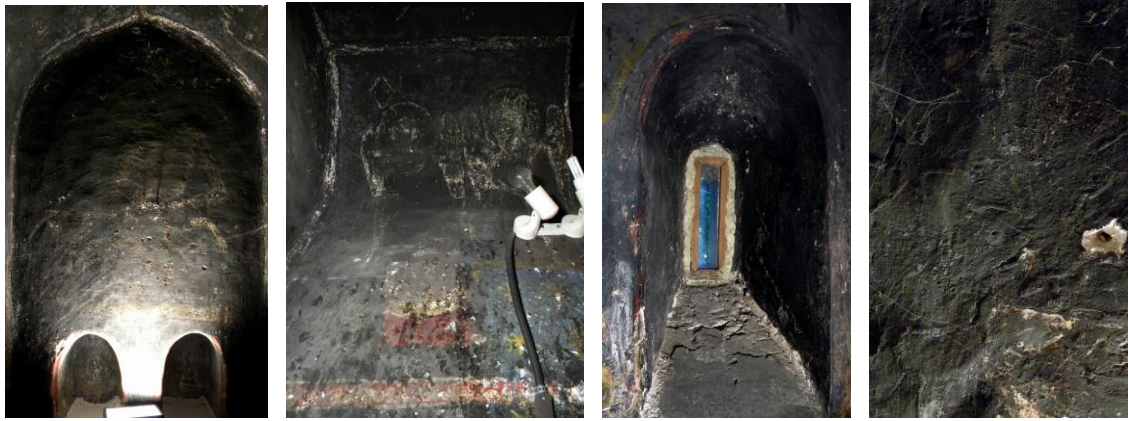
The whole surface of the paint layer on the walls of the Prothesis show extensive regions covered by an opaque black layer of dust, spider webs, smoke and tars, which drastically obscured the visibility of the wall painting decoration⁷³. Multiple types of foreign metallic materials were also identified, embedded in the structure of the preparation layers on the occasion of various “modernization” operations that affected the Prothesis, which operations culminated in the forceful insertion of a marble slab as washing table, in a space cut into the original fresco.

Figures 7, 8, 9. Opaque layers of superficial deposits on the scene “Christ in the tomb”, on the inner face of the vaulting, also in the window on the north wall. Figure 10. Spider webs - detail

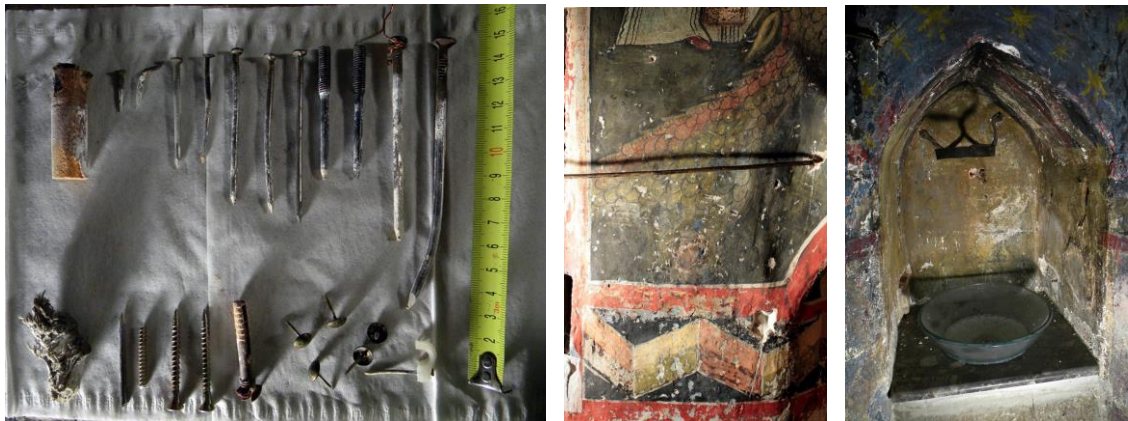
Figure 11. Foreign metallic materials taken out from the fresco Figure 12. Improved towel rack. Figure 13. The abusive “modernization” of the washing table

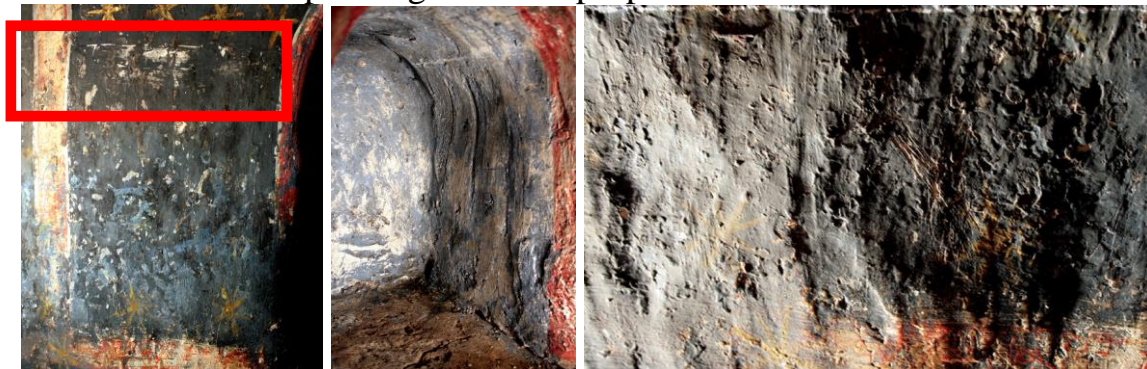
One of the aggravating collateral factors in the precarious state of conservation in the area of the Prothesis is the presence of technical faults in the execution of the murals, regarding both the negligent application of the paint in less visible areas and painting mistakes proper.

Figure 14. Red fascia wiped out and then covered with blue background by the painter

Figure 15. The negligent application of fresco on the lower niches

Figure 16. Detail of fresco application for the blue background

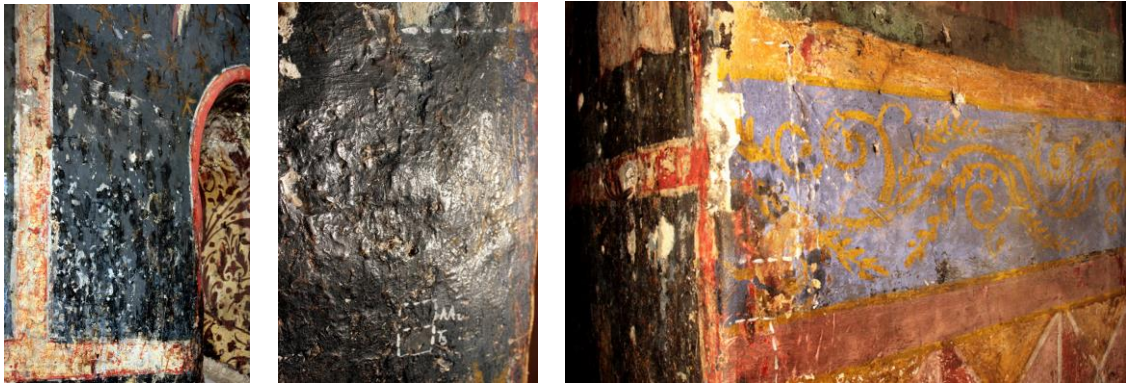
On almost the whole surface of the paint layer there were identified waxes of different types and degrees of strength, from “simple” drops or drips of melted wax, to layers of significant density on the side walls. In the case of median area of the north wall, the wax is deposited as “raindrops”, while on the south wall the wax deposit is a thick, stratified layer, with polished surface and localized insertions of textile fibers.

Figure 17. The “raindrops” wax deposits on the north wall Figures 18, 19. Stratified and polished wax deposits; Repainting using protein-based paint in the area of the ornamental belt

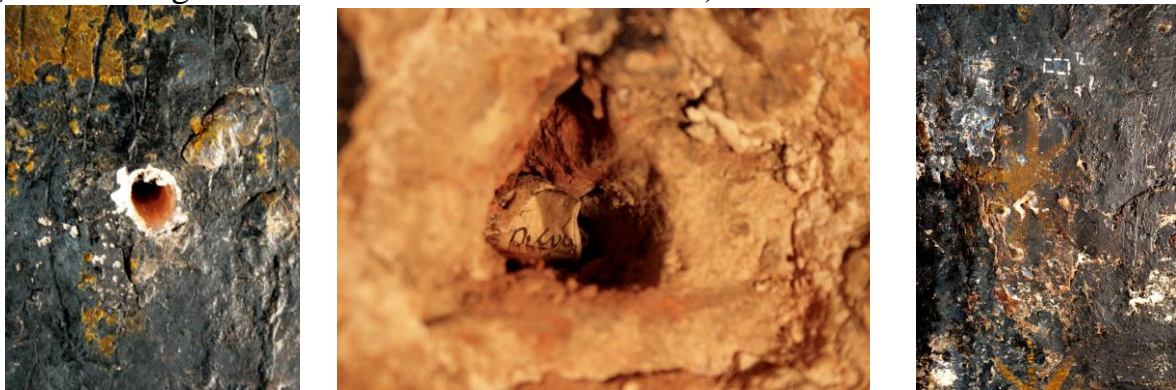
The analysis of the state of conservation also identified a series of localized repainting using protein-based paints (the ornamental belt, several architectural elements) that, in some cases, completely cover the wax deposits, as well as grouting of the preparation layers, made using a variety of improper materials (certain lacunae were “stuffed” with paper and then grouted over using a sand-based mortar, while several areas near the window in the north wall were grouted using hard Portland cement mortars etc.).

Figure 20. Wax deposits repainted Figure 21. Lacuna filled with paper Figure 22. Grouting with improper materials, covered by wax deposits, then painted over using protein-based paints

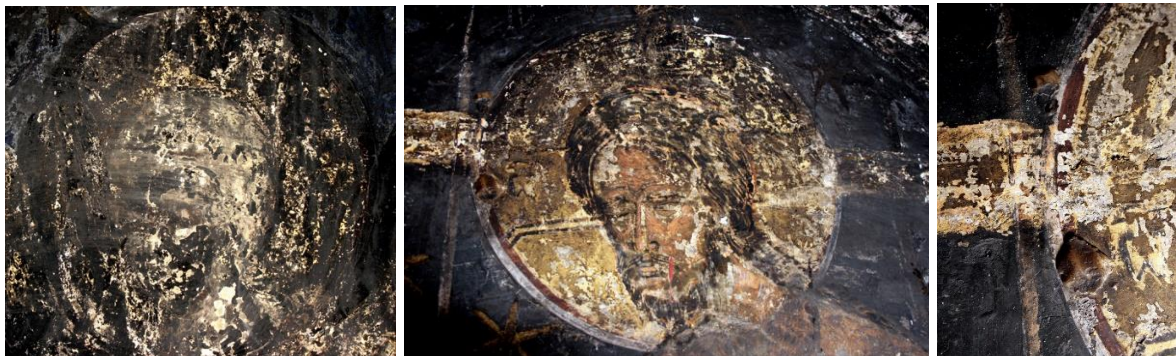
In order to complete the overview of the state of conservation in the Prothesis, one should include, as aggravating factors, the issue of flaking of the paint layer, combined with localized lack of adhesion of the pigments to the paint layer, which pulverization determined an intervention approach adequate to the situation.

Figure 23. The loss of adhesion of the pigment of the paint payer, before the restoration Figures 24, 25. Flaking and pulverization of pigments, after the first cleaning intervention

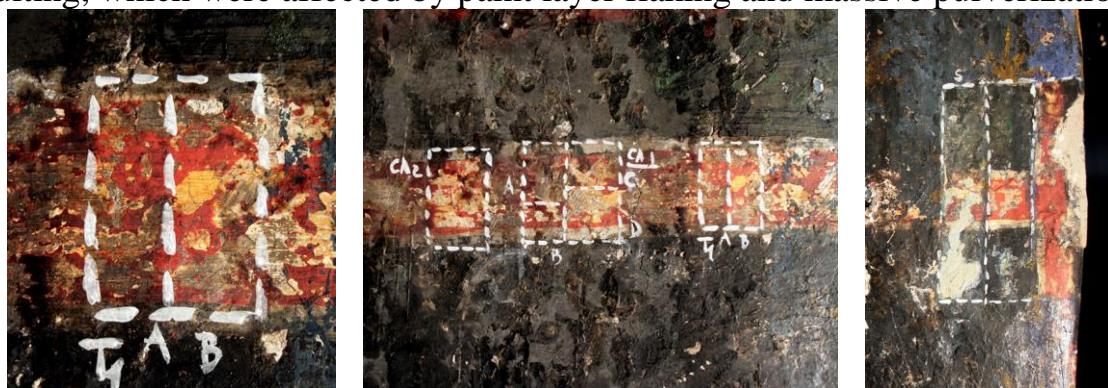
Figure 26. Solubility test on the superficial deposits – AA 10%

Figures 27, 28. Combined (chemical and mechanical) tests for the removal of lightly adhering deposits, using CA⁷⁶ 5-10% and solvents

Following the visual non-destructive investigation, using direct and raking light, which identified the main types of degradation present both on the paint layer and the preparation layers, the next step consisted in testing the adhesion to the paint layer of pigments and other potentially detaching elements, by lightly rolling a cotton-tipped bamboo stick⁷⁴, moistened with a 10% AA⁷⁵ solution, over the surface of the affected areas. According to the results of these tests, the first restoration operation consisted in the selective unloading of superficial airborne deposits, by means of soft-haired paint brushes, with special care required in the area of the Christ and angels portraits on the inner face of the vaulting, which were affected by paint layer flaking and massive pulverization.

Afterwards, several more deposit removal tests were carried out on the surface of the paint layer, using various solution concentration values, on successive rectangular test areas, combining different methods (chemical, mechanical or combined) according to the state of preservation of the surface. Consequently, the most effective intervention options were established, function of the results, bearing the lowest degree of risk to the paint layer surface.

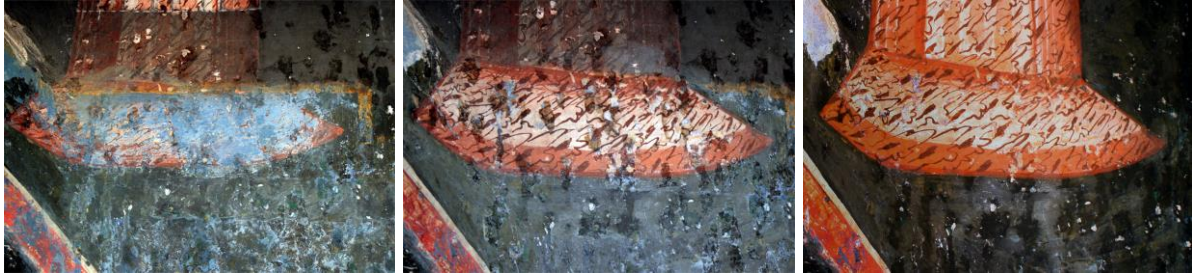
Figures 29 – 33. The successive stages of removal of wax and foreign materials deposits from the paint layer of the north (up) and west (down) walls in the Prothesis

In the case of wax deposits, two distinct methods were employed: a) on the areas with stable paint layer, the thick wax deposits were removed by mechanical means, in successive stages, then the remaining fine film would be

softened and removed by chemical means, by localized dabbing with xylene-type solvents and Solvapeint™; b) on the areas with unstable paint layer, the wax was softened and then removed exclusively by chemical methods: the solvents were applied locally, in successive stages, by means of pH-neutral paper film or paper paste pads, in order to avoid the risk of detaching the paint film.

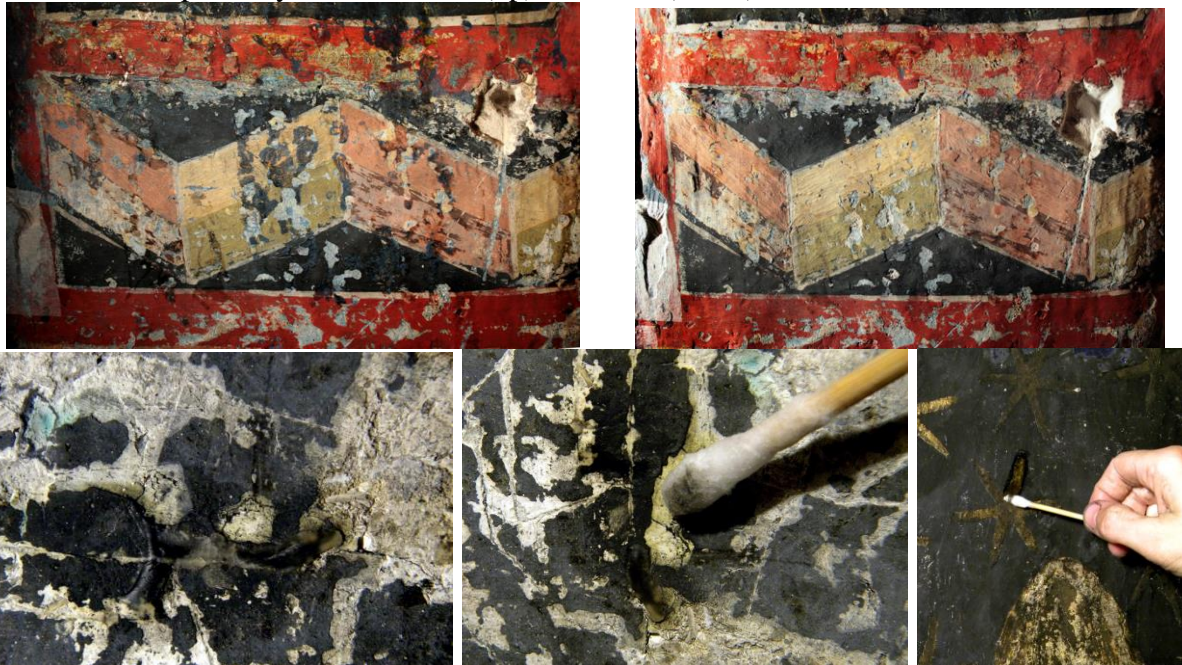
Figure 34. Wax deposits on unstable paint layer

Figure 35. Localized softening of wax deposits. Figure 36. Cleaning the gilding with 10% AA solution

Therefore, the areas with pigments sensible to acid or alkaline solutions⁷⁷, as well as the gilded areas were cleaned using AA solution, applied locally by cotton-tipped bamboo sticks, or by brushing the solution on pH-neutral paper pads, according to the characteristics of the surface. Special precautions were taken in the case of areas with flaking or pulverization (on the portrait in the scene “Christ in the tomb”), which required firstly the re-leveling of detached paint layer areas, by pressing-down with rubber rollers, through AA-impregnated Japanese paper pads. These areas were cleaned afterwards using also 10% AA solution on Japanese paper pads, reapplied at intervals sufficiently large to allow the partial re-adhesion to the paint layer of the flaked areas.

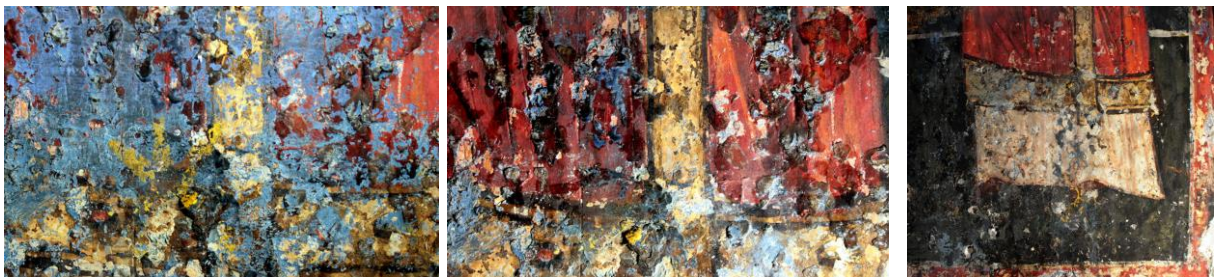
Figures 37 – 39. The south wall of the Prothesis: wax and resin deposits, covered by repainting hardened over time, operations during the restoration intervention

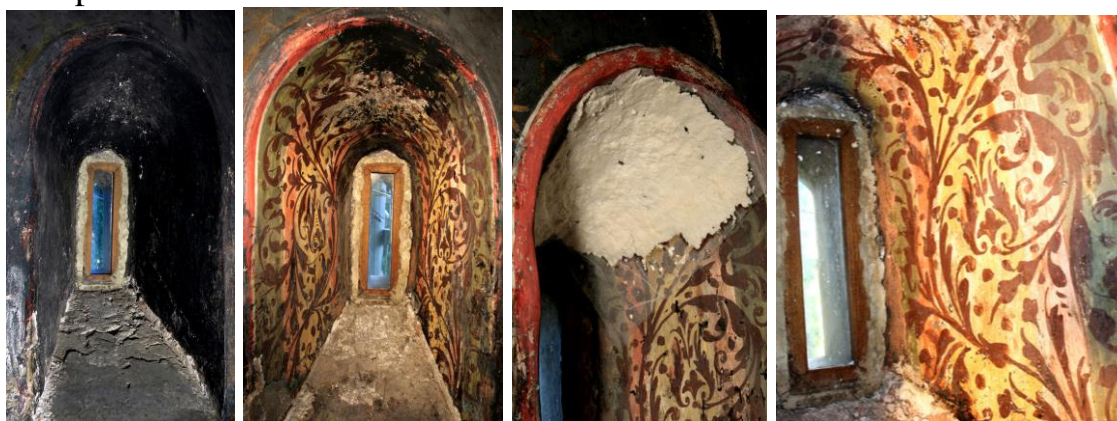
A very particular casuistic occurred in the area of the small window in the north wall: the inner face of its vaulting was covered by a combination of resin, tar and salt incrustation deposits, hardened by time and by the severe microclimate variations occurring in that space. The removal of these deposits required recurring interventions over several days intervals, using low-

Figures 40 – 43. The small window in the north wall of the Prothesis: the initial state of preservation (left) and the successive stages of removal of hardened deposits from the surface of the paint layer

concentration CA solution on paper pads acting though on longer periods. The eventual softening of the deposits was followed by mechanical removal means, i.e. scalpels and *bastoncini*.
